Stormwater Infrastructure Assessment and Capital Improvement Plan

Town of Esopus, NY

September 2019

Tighe&Bond
Engineers | Environmental Specialists

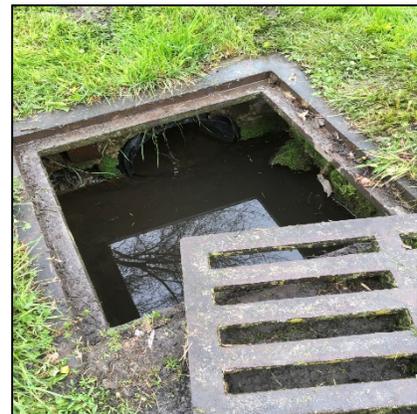
Figure 2-27 Site Visit Photo of Catch Basin Not Draining
