Stormwater Infrastructure Assessment and Capital Improvement Plan

Town of Esopus, NY

September 2019

Tighe&Bond
Engineers | Environmental Specialists

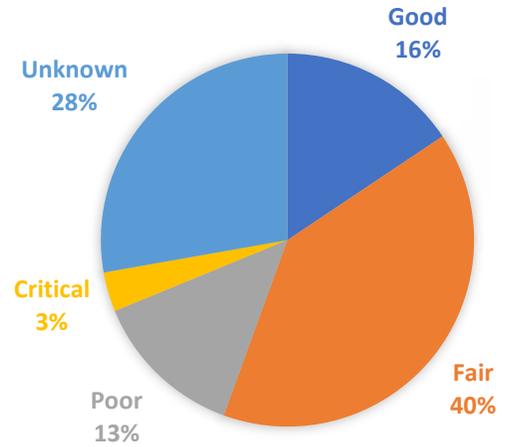
Figure 2-3 Distribution of Catch Basins Inventoried

The distribution of catch basins inventoried condition is categorized in Table 2-3 and Figure 2-3. Some of the catch basins of unknown condition exist in the Route 9W corridor which was digitized from record drawings and not field inventoried.

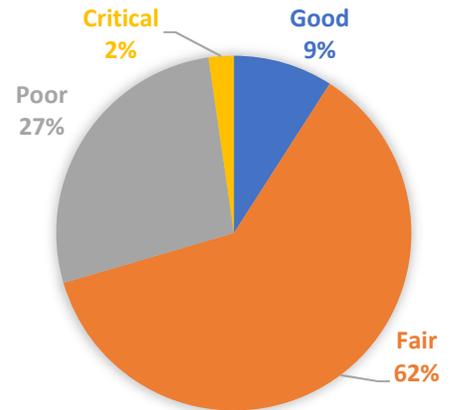
Figure 2-5 Distribution of Driveway Culvert Inventoried Condition

The distribution of driveway culverts inventoried condition is categorized in Table 2-5 and Figure 2-5. The distribution of driveway culverts inventoried material is categorized in Table 2-6 and Figure 2-6. Driveway culverts are those culverts that convey water from one side to another of a driveway within the right-of-way. It does not account for culverts on private property.

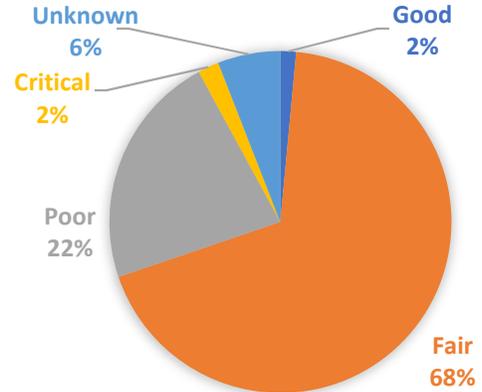
Figure 2-7 Distribution of Roadway Culvert Inventoried Condition

The distribution of roadway culverts inventoried condition is categorized in Table 2-7 and Figure 2-7. The distribution of roadway culverts inventoried material is categorized in Table 2-8 and Figure 2-8. Roadway culverts are those culverts that convey water from one side to another of a roadway within the right-of-way.

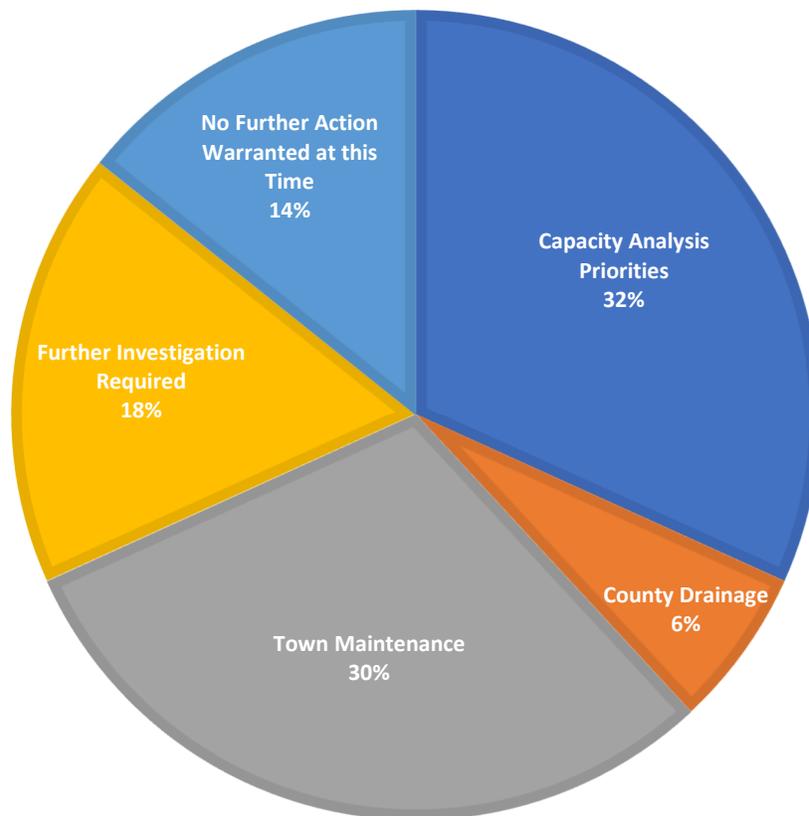
Figure 2-29 Reported Flooding Area Categorization

The information obtained through Tighe & Bond’s site visits indicates that many of the flooding issues had a common thread and that many of issues were consistent throughout an individual drainage watershed. Often times if one resident had an issue in a drainage watershed, residents adjacent and further downstream in the same watershed reported similar issues. Common threads of issues allowed Tighe & Bond to take a more comprehensive look at stormwater system issues rather than making recommendations to address one property at a time. There were 20 properties (32%) with reported flooding issues that fell into the Capacity Analysis Priorities category.

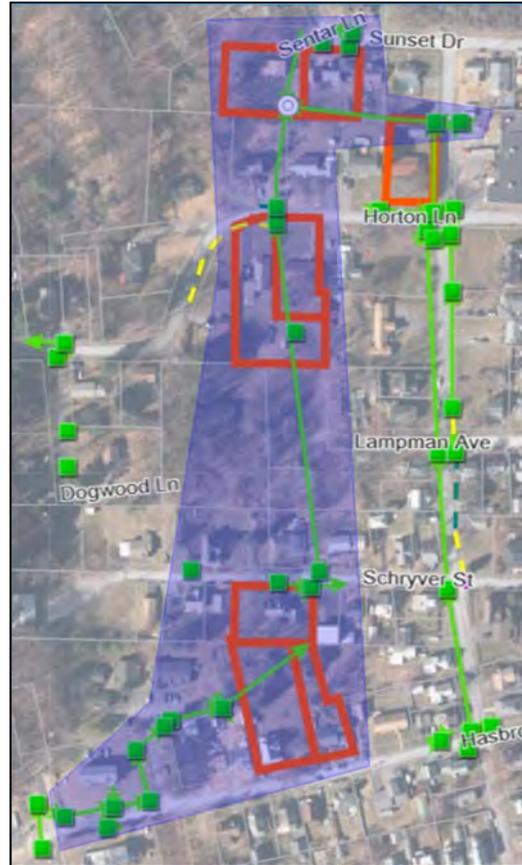
Figure 3-1
Salem-Sentar Modeling Extent

The Salem Street to Sentar Lane area of the stormwater system consists of the pipe drainage network that connect a large portion of Port Ewen between Salem Street and Sentar Lane. Runoff from Hasbrouck Avenue and surrounding hillsides is collected in a piped drainage system that runs in two parallel mains, one along Bayard Street and the other through private properties. These two lines converge at a manhole on private property between Horton Lane and Sentar Lane from which stormwater is discharged into an existing stream. Drainage easements reportedly exist for portions of this stormwater system on private property. Flooding in this area is reported to affect the following properties, but others may also be impacted:

- 186 Hasbrouck Avenue
- 182 Hasbrouck Avenue
- 183 Schryver Street
- 179 Horton Lane
- 173 Horton Lane
- 170 Horton Lane
- 169 Sunset Drive
- 169 Sentar Lane

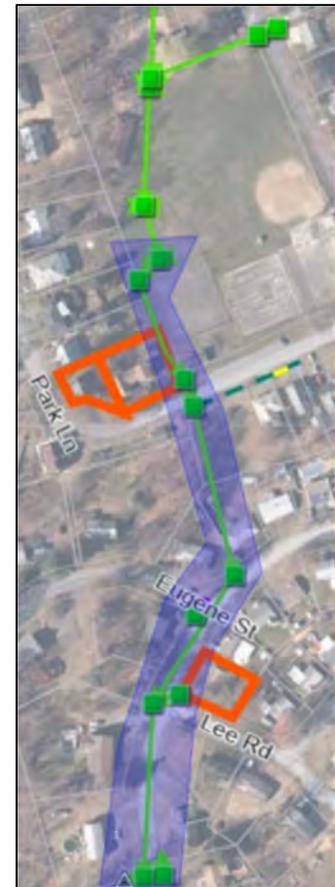
Figure 3-2 Eugene-Doris Modeling Extent

The existing conditions analysis indicates 2 structures are surcharged in the Eugene Street System during the 2-year and higher intensity storms. The model indicates that flooding is caused by undersized pipes. Pipe sizes in this system vary

between 6 and 18 inches but have sections where larger pipes discharge to smaller pipes. The convention for gravity drainage piped systems is to have pipe sizes increase moving downstream as more and more drainage watershed contribute to the collection system.

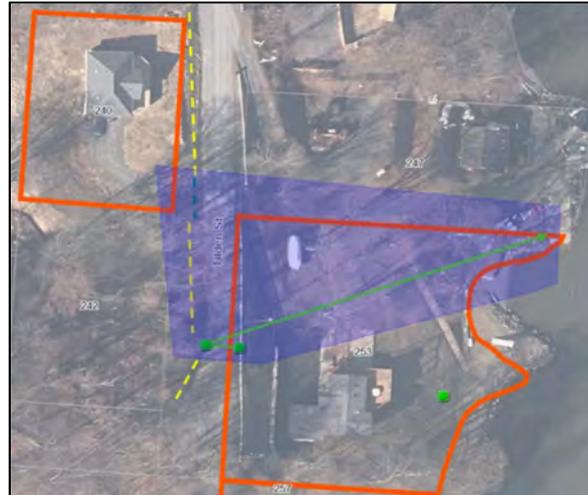
Figure 3-3 Tilden Street Modeling Extent

The existing conditions analysis indicates that the Tilden piped system under all assessed storm events (2, 5, 10, 25, and 50-Year) has sufficient capacity. However, the amount off runoff that is generated during the higher intensity storms exceeds the inlet capacity of the two catch basins that exist in Tilden street. In addition, the existing shallow swale does not have sufficient capacity during heavy rainfall events. It was reported that a natural gas main runs under the swale on the west side of Tilden, prohibiting deepening of the existing swale.

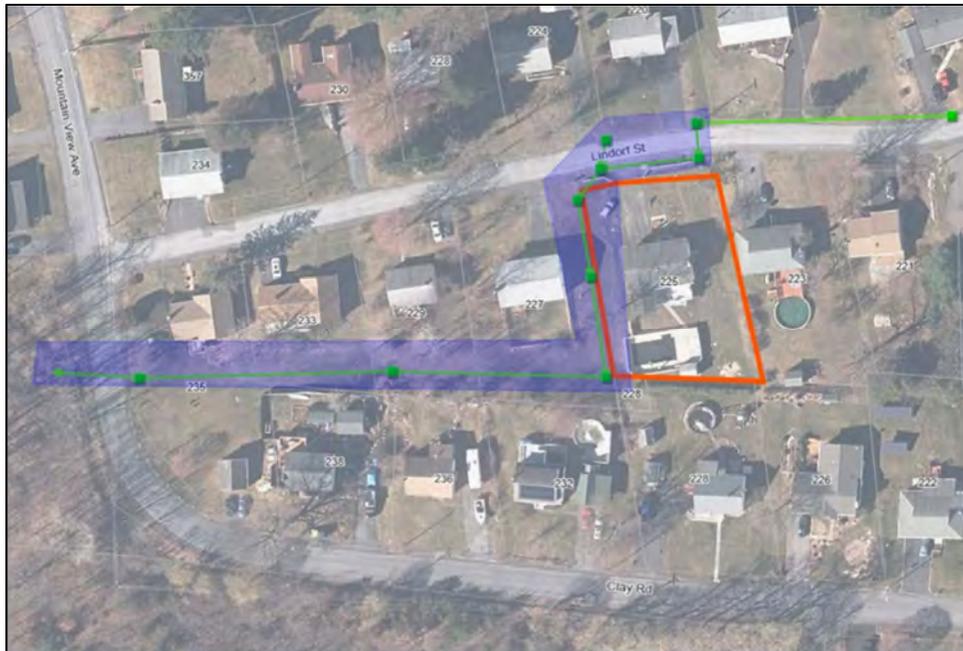
Figure 3-4 Lindorf Street Modeling Extent

The existing conditions analysis indicates that 6 structures in the Lindorf Street System are surcharged during the 2-year and higher intensity storms. The model indicates that flooding is caused by undersized pipes. Site visits to the area also indicates that some catch basins are set higher than the surrounding grade, restricting runoff from entering the piped system. All existing drainage pipes in this system are 12-inch diameter.

A concept improvement alternative was developed to convey stormwater through the system during a 25-year storm without surcharging. The concept improvement includes the replacement of portions of the existing 12-inch piped system with increasing sized pipes further downstream. The proposed replacement includes the most downstream eight structure-to-structure segments of pipe with portions of 36-inch and 48-inch diameter pipe. In addition, the improvement alternative includes replacement of the structures along this length of replaced pipe to accommodate the large size pipes and provide positive slope. If the Town decides to extend the existing stormwater system further upstream along Lindorf Street to receive flow from resident's sump pumps; however, this system extension is not included in the concept improvement alternative. As previously mentioned in this report, managing groundwater is not typically the responsibility of municipalities.

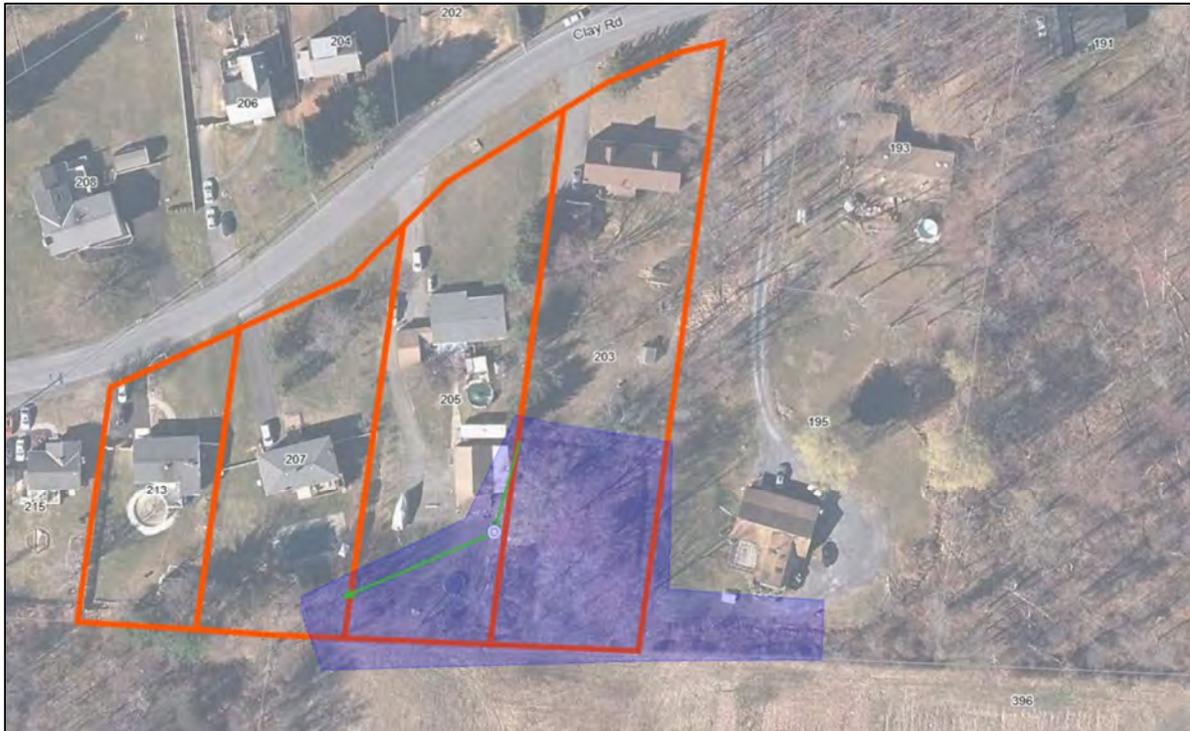
Figure 3-5 Clay Road Modeling Extent

The Clay Road area of the stormwater system drainage watershed consists of a swale that contributes runoff to a screened end of a pipe, which conveys stormwater around several residential structures and discharges to another downstream swale. Water enters the upstream screened end of the first pipe segment at a skewed angle. Runoff from a watershed extending up to Route 9W, but not directly impacted by Route 9W drainage system, collects in a pond on private property on Clay Road. From there, the water is conveyed through the Clay Road system until its discharge in the downstream swale. The Town reportedly installed this drainage system to alleviate flooding in the area; however, no easement was found filed on the land records. Figure 3-5 shows the extent of the portion of the stormwater system for which the capacity analysis was performed.

The existing conditions analysis indicates that both drainage structures in the system are surcharged during the 2-year and higher intensity rainfall storms. The model indicates that flooding is caused by undersized swales and pipes. All pipes in this system are 12-inch diameter.

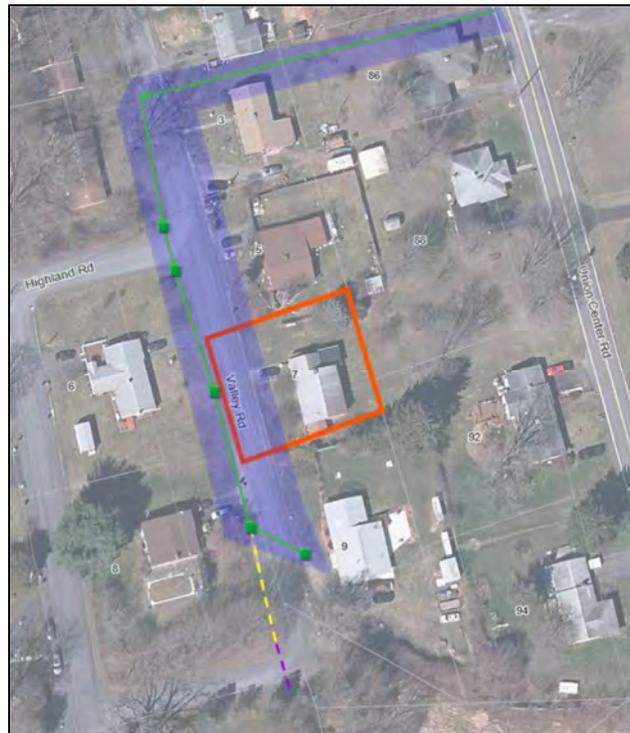
Figure 3-6 Valley Road Modeling Extent

The Valley Road area of the stormwater system consists of drainage watershed that contributes stormwater to the piped drainage system on Valley Road. Runoff from Highland Road and the watershed that contributes to Valley Road is collected in a piped drainage system on Valley Road and conveys runoff to a discharge point under Union Center Road to a downstream water course. One segment of the existing drainage system runs between private property. No sumps exist on the existing catch basins and they are smaller, there is also a buried manhole along the stormwater system. A drainage easement exists for the system on 3 Valley Road. Flooding in this area is reported to affect the following properties, but others may also be impacted:

The existing conditions analysis indicates that 4 catch basins surcharge during the 2-year and higher intensity storm. The model indicates that the flooding is caused by undersized pipes in the drainage system. Drainage pipes in the Valley Road stormwater system are either 6-inch or 12-inch diameter.

A concept improvement alternative was developed to convey stormwater through the system during a 25-year storm without surcharging. The concept improvement includes replacement of a portion of the existing drainage pipes so that they increase in size from upstream to downstream. The proposed improvement includes replacement of seven structure-to-structure segments of pipe in the system along Valley Road and Highland Road and replacing them with new pipes of larger sizes (24 inches and 30 inches). Additionally, the proposed improvement includes replacing the existing structures along this length of pipe and replacing the existing two segments of pipe on Highland Road that connect to the Valley Road system. The proposed drainage pipe that currently runs through private property is proposed to be rerouted along Valley Road to William White Road then east to Union Center Road to its current outfall. Table 3-7 details the opinion of probable cost to design and construct the concept improvement alternative.
